248-nm UV Damage Mechanism in MPP CCD's

Nixon O, Jonathan Huras, Sukhbir Kullar, Saladin Sahinovic

DALSA Inc.

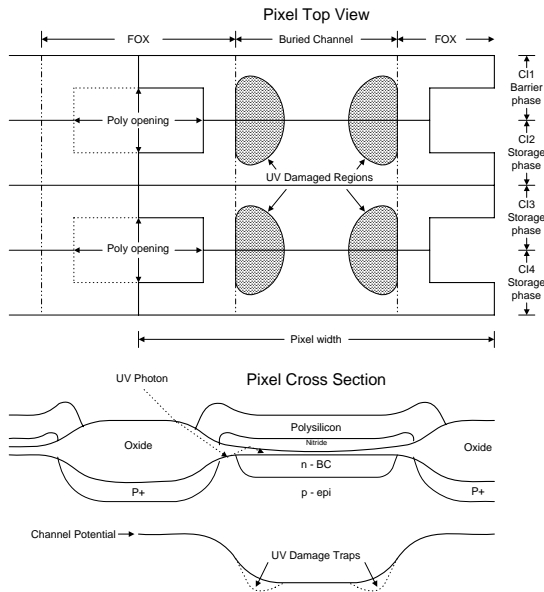
UV Damage Location in the Photosite.

The damage is located in the area adjacent to the poly openings as illustrated in Figure 1. We have approximated the reach of internally reflected UV photons.

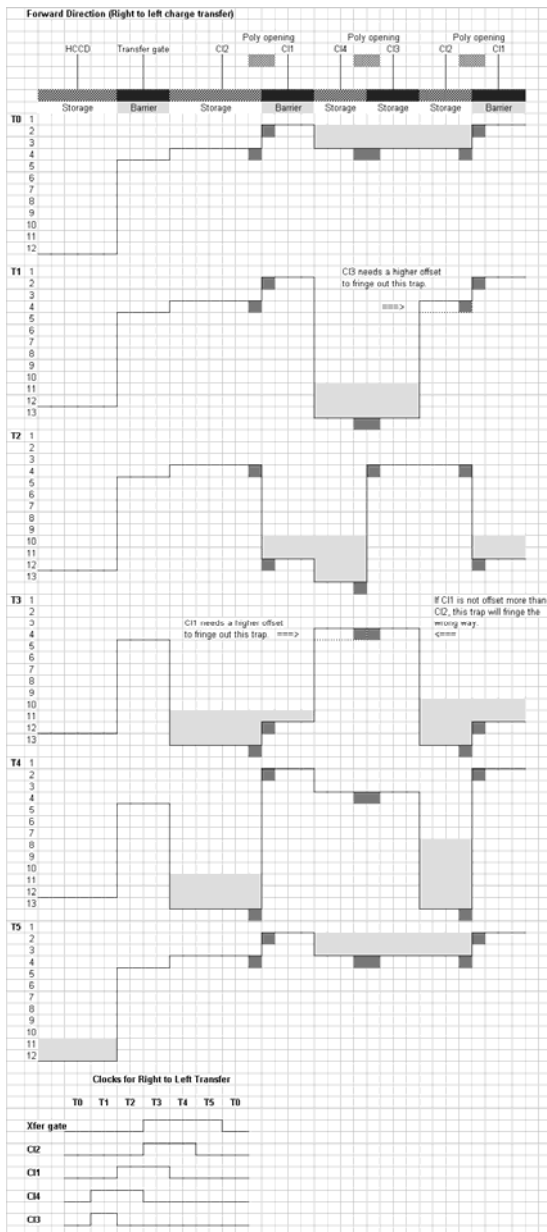
In the forward direction, there are two biases (CI1 and CI3 high) that affect CTE. In contrast, there is only one bias (CI2 high) that affects CTE in the reverse direction. This asymmetry is a result of the asymmetry in the location of the poly openings. On the T3 forward direction, the difference in the CI1 and CI2 high potentials can cause charges trapped in the CI3/4 interface to fringe the wrong way, i.e. back to CI2. The same does not happen in the reverse direction because there is no poly opening in the CI2/3 interface. If hypotheses 1 or 2 were correct, there should be no asymmetry in the number of biases that affect CTE in the forward and reverse directions.

Figure 2.
MPP CCD potential well diagram illustrating UV-induced potential packet locations. Forward direction charge transfer is shown. The dark boxes in the potential well indicate potential trap locations.

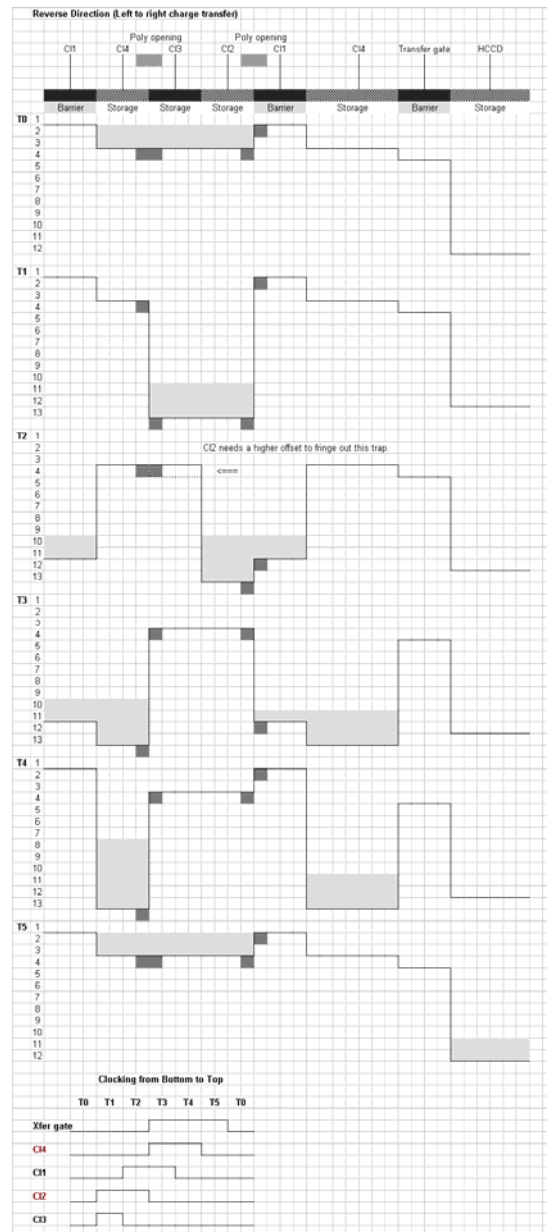
Figure 3
MPP CCD potential well diagram illustrating UV-induced potential packet locations. Reverse direction charge transfer is shown. The dark boxes in the potential well indicate potential trap locations.
